New Delhi, India 24-26 May, 2022

NEW TECHNOLOGIES AND INNOVATIONS IN RURAL ROADS

Gordon R. Keller, PE, GE
Geotechnical Engineer
GENESEE GEOTECHNICAL
gordonrkeller@gmail.com

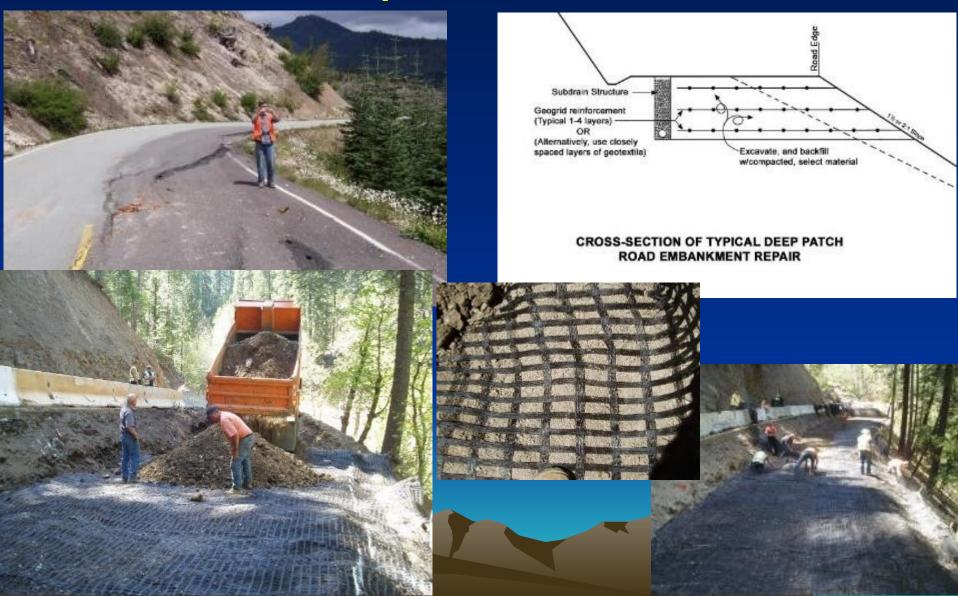
Deep Patch

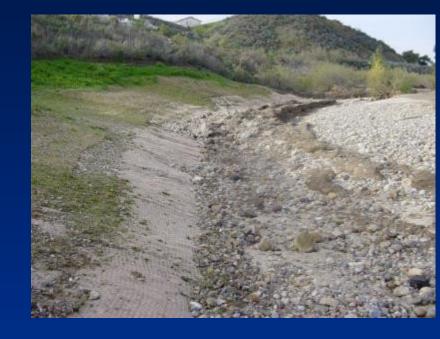
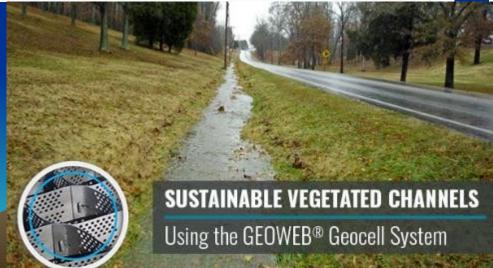
Road and drain incorporated. Drain can also be to side of road. (Hall & Hall 2007).

Dimpled formwork creates interlock between cells poured in situ (thin geocell formwork). (Hall & Hall 2007).

Strips of thick (>20 mm) geocell formwork (National Rural

Geocell formwork expanded and tensioned and ready

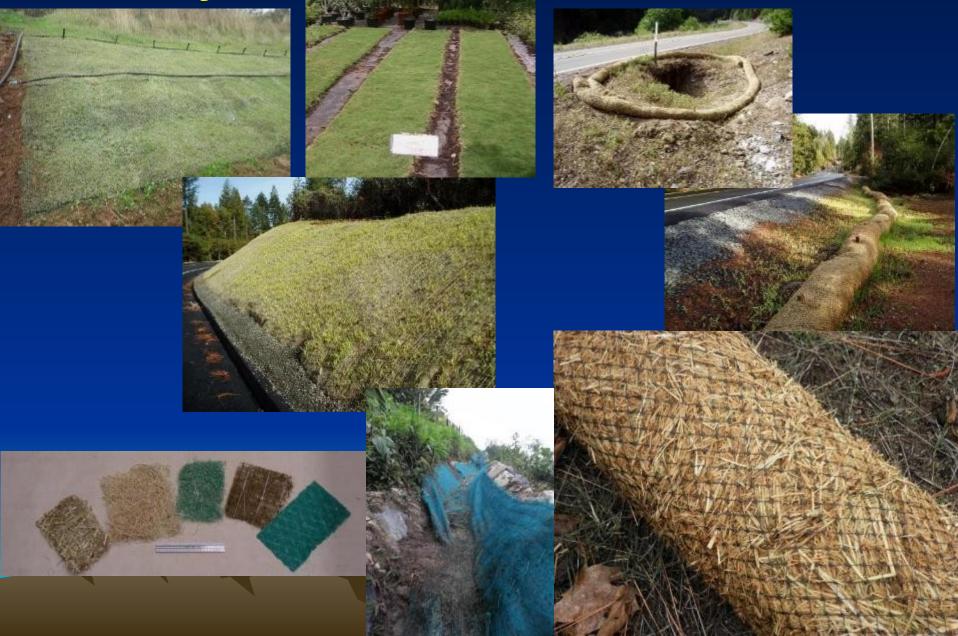
Geosynthetic Erosion Control Products

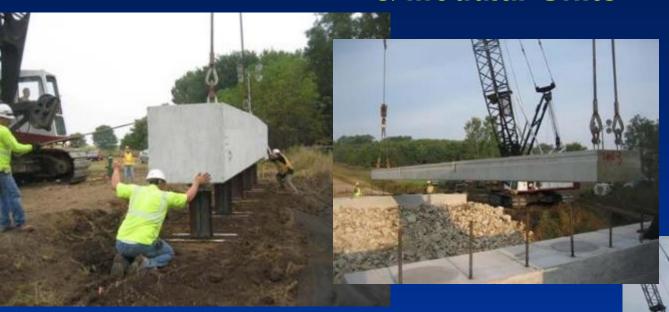
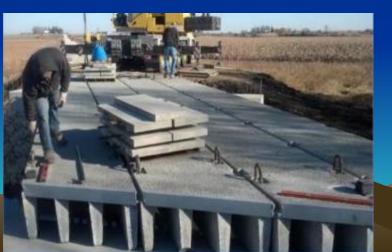
Accelerated Bridge Construction (ABC) & Modular Units

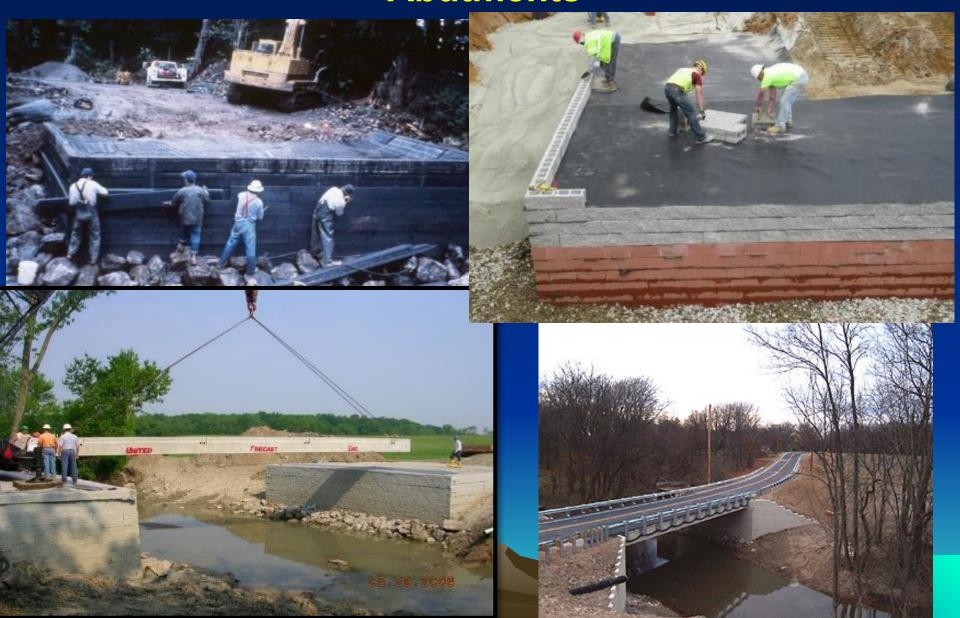
GRS-IBS Abutments

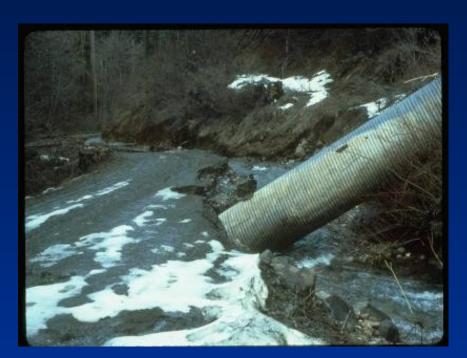
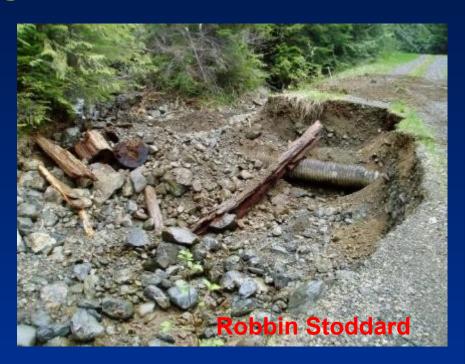
Fill Overtopping Protection

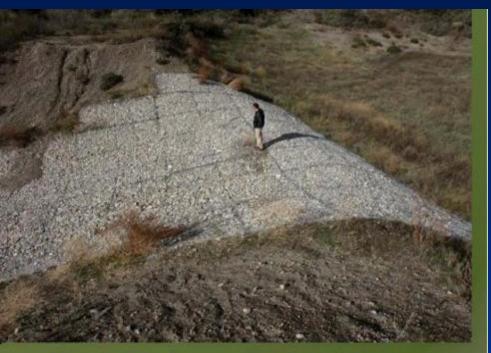
Overtopping Protection

Rock Mattress 6 Years Later

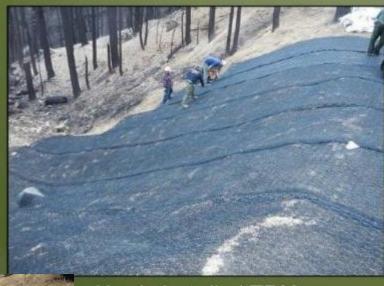
Newly Installed TRM

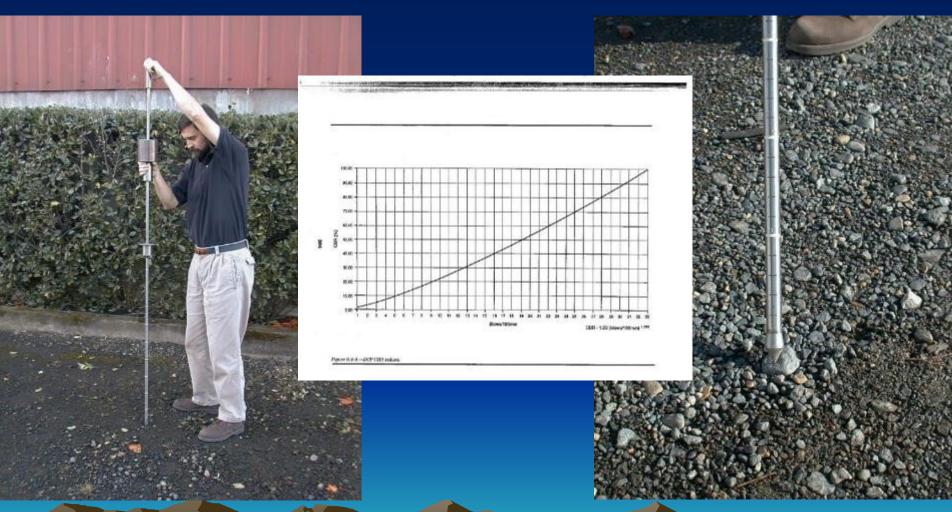
Dynamic Cone Penetrometer DCP

DCP-DN Design

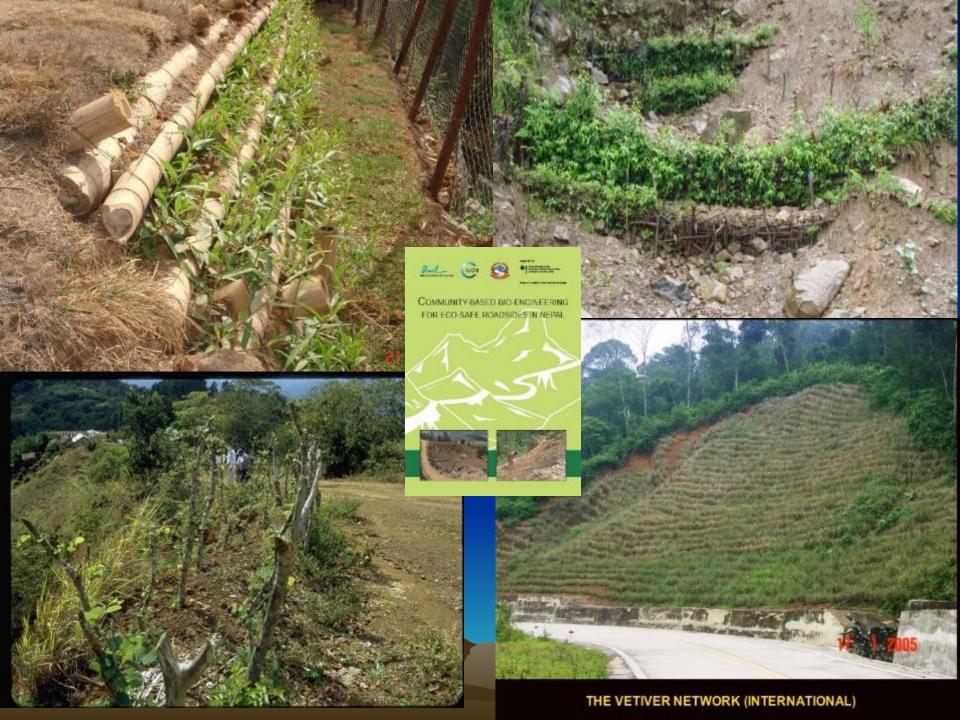
Perspective View of Slope with Brush Layering

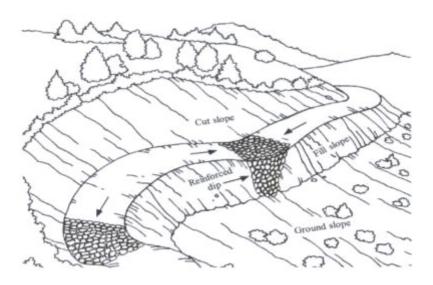
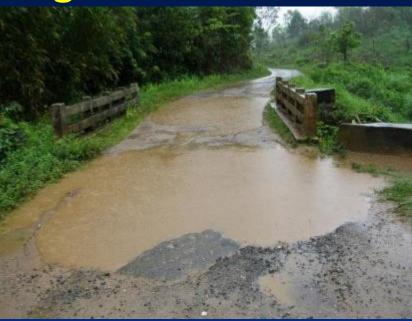
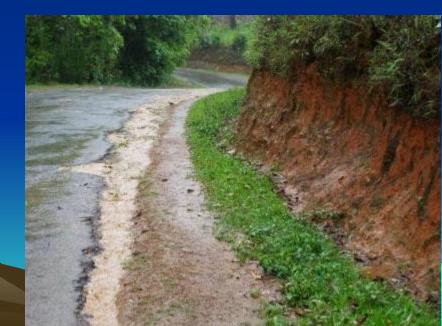
Typical Road Surface Drainage Options
