**RSA REPORT ATTACHMENT
(PART 1: ROAD INFORMATION)**

State: Madhya Pradesh
District: Sagar
Block: Banda
Road Number (Core Network):
Construction Package MP 33-503
Number or DPR reference
number:
Road Name: B07 to Hinoti
RSA Stage: DPR Final Design
Road Length 1.25km

(PART 3: ROAD SAFETY AUDIT FINDINGS)

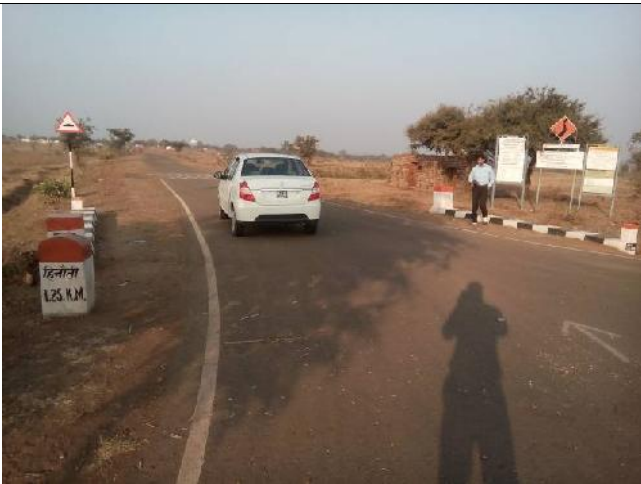
Safety Issue No 1	
B07 to Hinoti	
Location	
Chainage 0.00 at beginning point	
Description of Road Issue	
No issue identified

Recommendation to Address the Issue
There is proper demarcated road edge and provide speed breaker and painted with white band

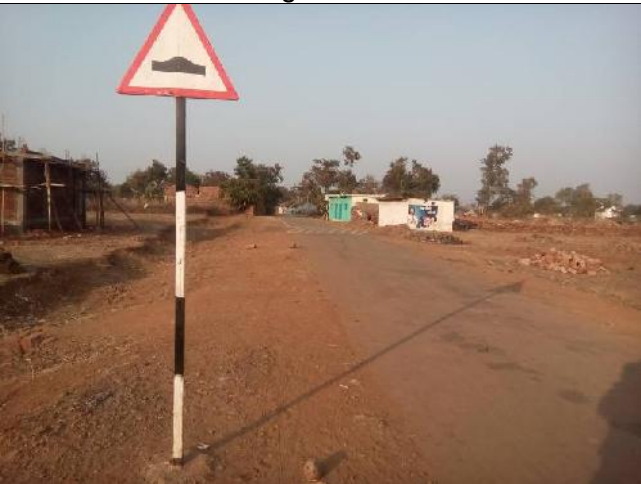
Safety Issue No 2
Speed Breaker
Location
Chainage 1000m
Description of Road Issue
Proper speed breaker and demarked with the sign board

Resulting Road Safety Risk: (1) <i>Combined rating equals sum of exposure rating plus probability rating plus consequence rating divided by 3. Higher the combined rating, greater the urgency of attending to the road safety issue.</i> Scale: 1 - very low, 2- low, 3 – medium, 4 – high, 5 – very high
Recommendation to Address the Issue
Speed breaker proper demarcated and put sign board of speed breaker

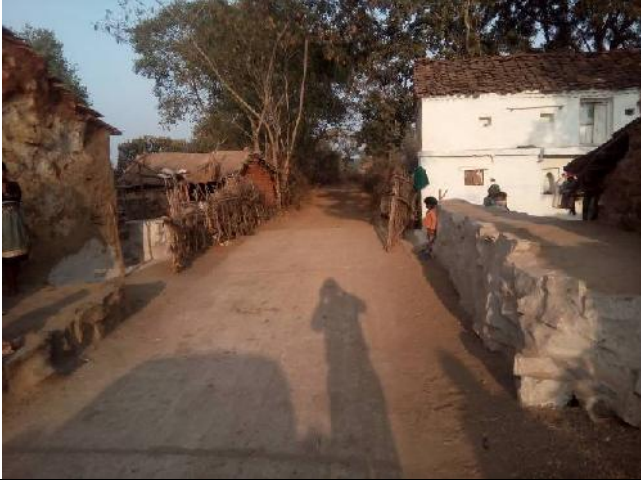
Safety Issue No 3	
Habitation area	
Location	
1.25m	
Description of Road Issue	
Road end point

Road Safety Risk	
Exposure to Safety Issue: (3) <i>Estimated as potential for traffic conflicts (e.g. braking, swerving, etc) caused by the issue</i> <i>Scale: 1 - very low, 2- low, 3 – medium, 4 – high, 5 – very high</i>	
Probability to Cause Accident: (3) <i>Estimated as probability of traffic conflict resulting in an accident</i> <i>Scale: 1 - very low, 2- low, 3 – medium, 4 – high, 5 – very high</i>	
Consequence of Accident: (3) <i>Estimated likelihood of personal injury or death caused by accident. Involvement of pedestrians/bicyclists versus vehicle would have severe consequence. If trucks are involved, the consequence would be even more severe. High speed of potential impact would have severe consequence.</i> <i>Scale: 1 - very low, 2- low, 3 – medium, 4 – high, 5 – very high</i>	
Resulting Road Safety Risk: (3) <i>Combined rating equals sum of exposure rating plus probability rating plus consequence rating divided by 3. Higher the combined rating, greater the urgency of attending to the road safety issue.</i> <i>Scale: 1 - very low, 2- low, 3 – medium, 4 – high, 5 – very high</i>

Recommendation to Address the Issue	
Road is passing with the close habitation area and there is required speed limit sign board.
