# Grameen Sampark

**Pradhan Mantri Gram Sadak Yojana**

# Abstract

# Studies On The Effect of Admixtures AND INTERFACIAL BONDING LAYER on Bond Strength of ULTRA THIN White topping OVERLAYS

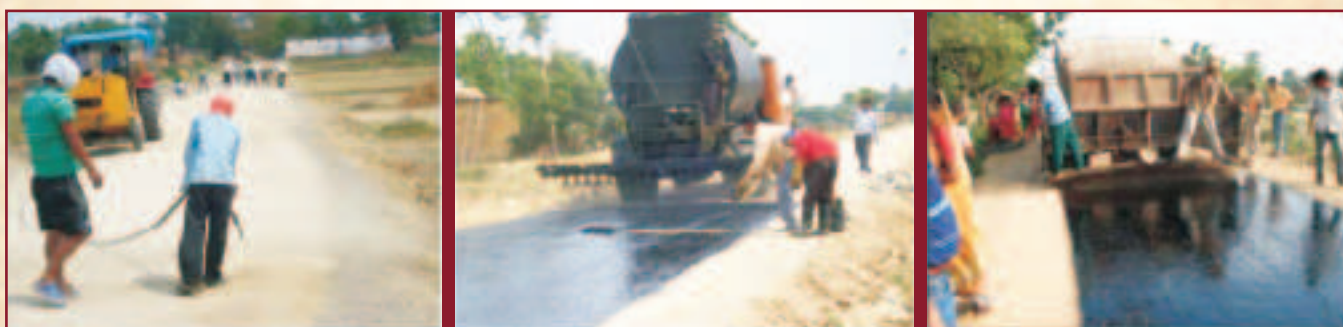
FIGURE 2. Otta Seal Laying Process cleaning, bitumen spray and chips spreading.

The construction operations are mechanized for grading of the sub grade, sub-base lying with compaction, bitumen spraying, chips spreading and rolling (Figure2). Where proper construction equipment was not available on time for some district roads, bitumen and chips spreading were being done manually. However, compaction was done with pneumatic rollers and steel rollers. Brushing and cleaning of the finished sub-base are carried out through labor. These manual

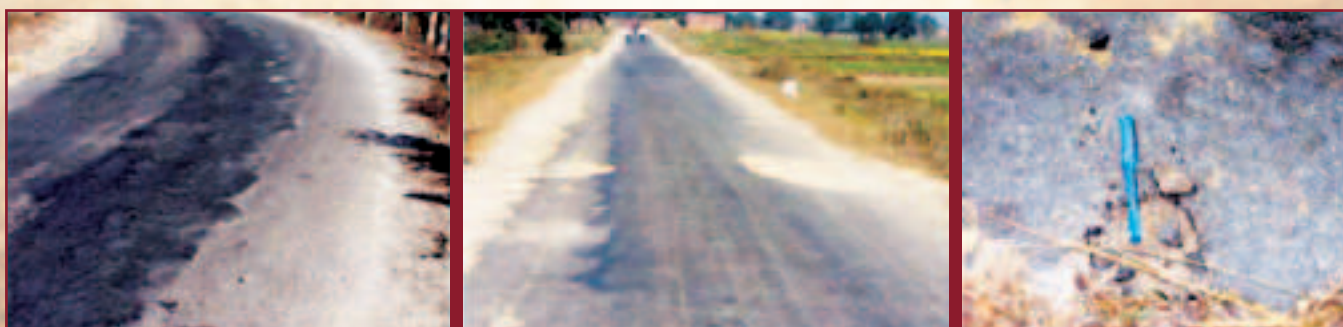
**FIGURE 4. Rutting, potholes and scaling.**

Some premature failures of raveling, stripping, rutting were also observed for poor quality of works. Proper grading of chips, quantity and quality of bitumen are important factors for better performance. Scaling and stripping of Otta Seal are associated with the bleeding of sealed surface. Such problem occurred only at few locations. Inadequate preparation and compaction of the sub grade or fill material are other causes of failure of pavement (Figure 4).

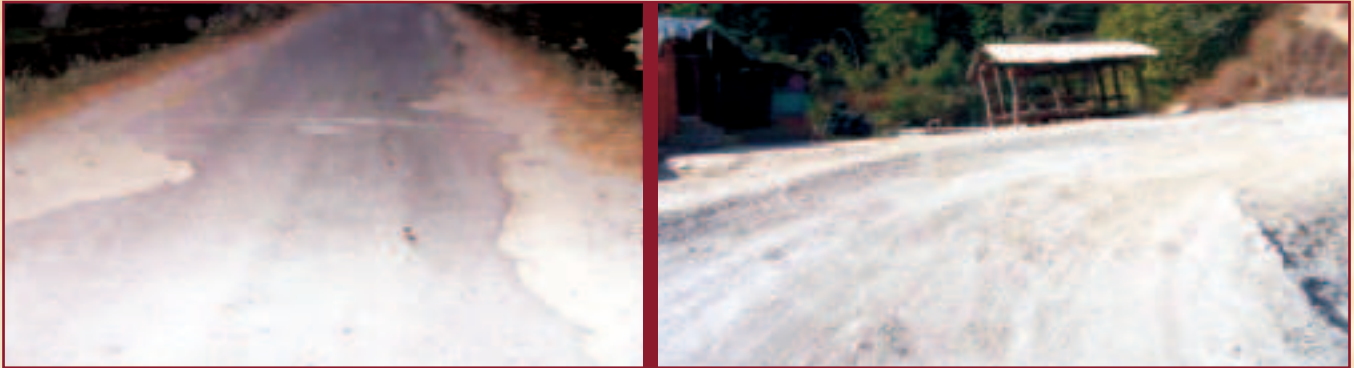
FIGURE 5. Edge breaking and raveling on curves.

Road geometry is another reason observed for the failure of Otta Seal. Raveling is quite common in the steep gradient, sharp turnings and braking zones (Figure 5). The damage is more in the early days of Otta Seal, when the vehicular speed is not controlled. Since all the

roads upgraded were single lane, edge breaking is significant in the plain area because of high speed vehicle driven at while crossing the vehicles coming from opposite direction.

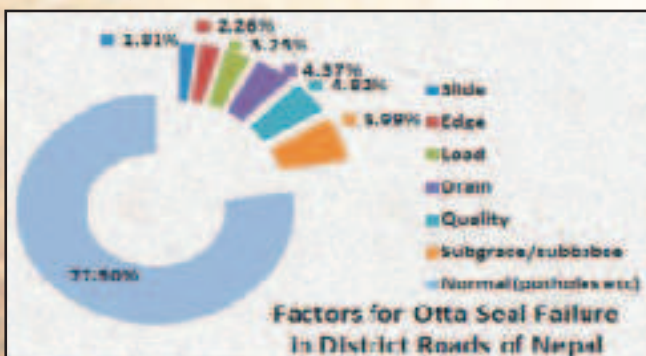
FIGURE 7 Different failure types by percentage occurrence.

The causes of failure and their contribution on Otta Seal pavement performance in the District Roads as recorded by DOLIDAR are presented in Figure 7.

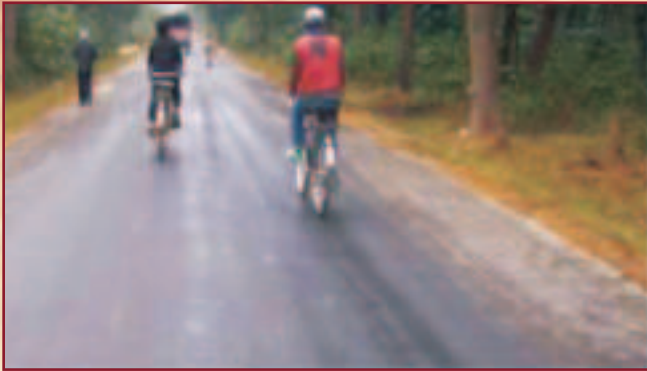
**FIGURE 8 Otta Seal after Seven Years**

Overall Otta Seal is performing well, especially where roads have been stabilized in terms of water management and geology. Some roads are still in fair condition after 7 years of construction without any maintenance attention (Figure 8). Anecdotally, about 1/4 of the roads have severe damage between 1-2 years (rutting, bleeding, scaling, washouts, cracks, subsidence), 1/4 length medium damage in 2-4 years (edge breaking, raveling, stripping, potholes) and about half of the roads normal damage in 4-7 years (potholes, stripping etc). Otta Seal has worked well where re-gravelling was done on existing gravel surface. The performance is relatively better in plain and dry area.

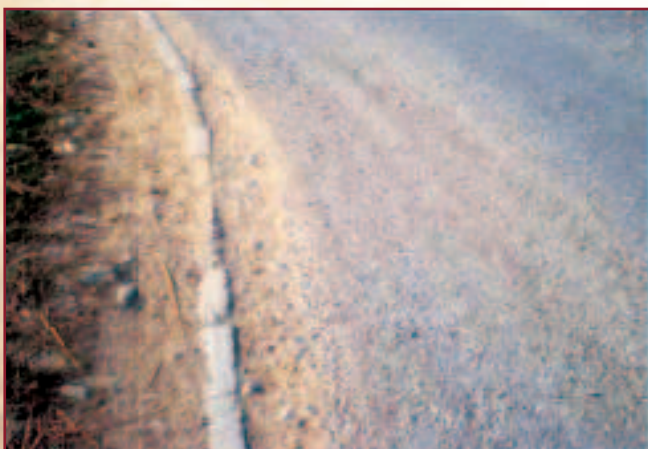
**FIGURE 9 Concrete edging**

In case of the districts, there is no luxury on construction cost to fulfill all the engineering requirements including adequate water and pavement structures for their roads. Based on the lesson learned, the districts are allowed to use Otta Seal only for upgrading existing gravel road. That too is governed by anticipated traffic volume and sub grade strength. Sand seal is now made mandatory in hill roads and concrete edging in the plain of Terai. (Figure 9). These provisions have improved the performance.

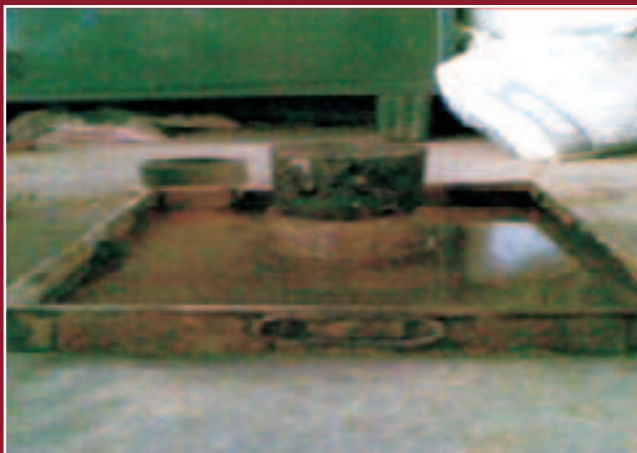
**Photograph 1 Curing of Composite Cylinder**

carried out according to IS: 10262-1982. Homogeneous concrete mass was prepared as per the mix design. This mass was gently placed on the Bituminous base in layers and consolidated by using just the required vibration for good compaction. After consolidation the surface was finished smooth and was covered with wet gunny bags. After 3 days the specimen was demoulded and transferred to the curing tank. After curing for 7 days and 28 days the specimens were tested for their respective bond strengths. The dimensional details of the composite cylinder specimen and the picture of the mould are shown in Fig.2. A picture of composite cylindrical specimen in curing tank is shown in Photograph 1. The cylindrical composite specimens having 75mm thick concrete layer over 75mm thick bituminous layer were subjected to direct tensile test by clamping the specimens with specially designed clamps, which could hold the specimen and could be clamped on to UTM for conducting the test. The clamping arrangement for conducting direct tensile test is shown in Photograph 2.

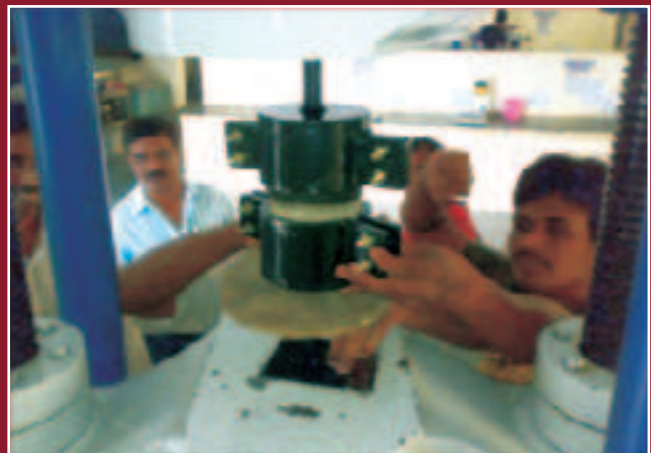
**Photograph 2 Clamping Arrangement**

To determine the effect of these admixtures on the bond strength between Bituminous Concrete and cement concrete layer, the specimens were subjected to direct tensile test by fixing the specimen onto the UTM
